Operations Notes FOS Team @ ESAC

Topic: Date: Issue: FOS Report for week 28, year 2016 from 11 JUL 2016 to 18 JUL 2016 1.0

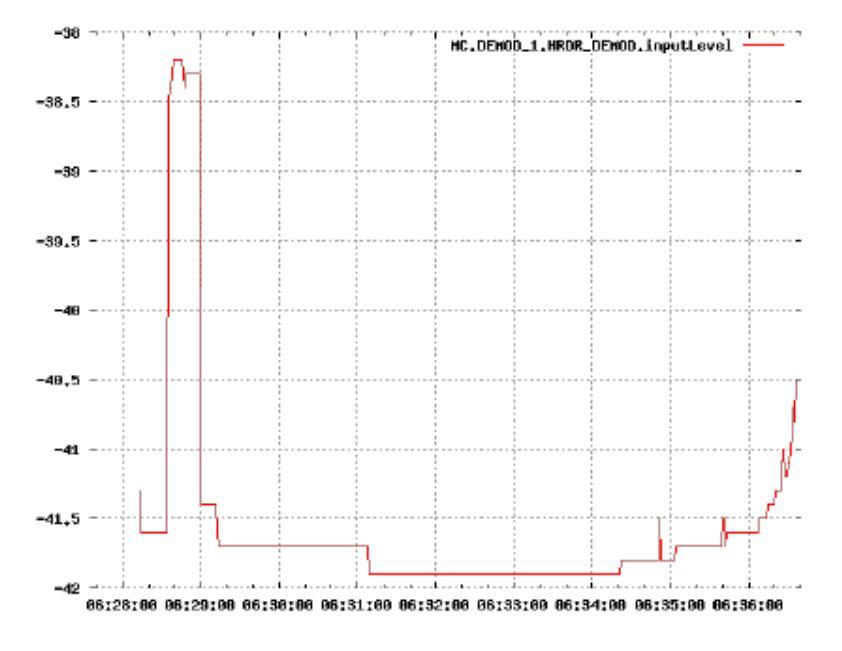
Figure 1 Demodulator input level

As result of this failure no data was received on ground for the affected pass. During the first SBand pass after the reset, AOS=09:35z, and before the recovery of the instrument, it was checked that the instrument was nominally working with no any other alarm and with the onboard Write pointer nominally progressing. A visual inspection of the OBSW code showed that the problem could be a Low Level Software problem caused by a possible late response of the hardware or a direct RTEMS LLSW problem. The data from the XBAS antenna at ESAC also showed a short carrier peak at the start of the pass compatible with the low power peak seen at instrument level (see Figures from 1 to 3).
